Manhole Inspection Summary

Manhole # S250__005MH

Insp Date: **4/4/08 1:03 PM**

Location Address: **1361 WARD ST.**

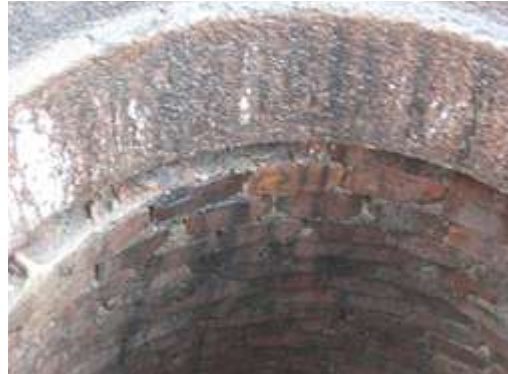
Defect 2

Infiltration: ☐ None ☐ Joint ☐ Cracks ☒ **Mortar** ☐ Roots ☐ Wall

Infiltration: ☐ None ☐ Joint ☐ Cracks ☐ Mortar ☐ Roots ☒ **Wall**

EVIDENCE OF INFILTRATION AT
CHIMNEY MORTAR AND CORBEL
WALL

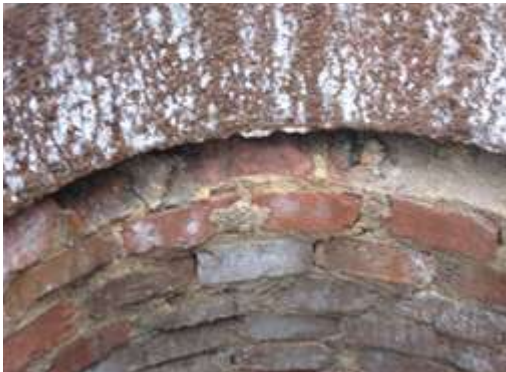
Defect 1

Condition: ☐ Sound ☐ Cracked ☐ Root Intrusion ☒ **Loose Brick** ☒ **Deteriorated**

CHIMNEY LOOSE/MISSING MORTAR &
BRICKS

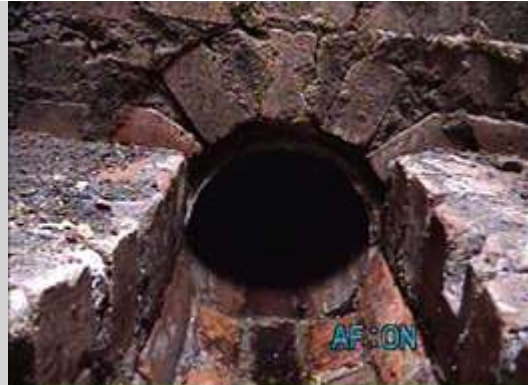
12 O'Clock Outflow

Pipe Height: **8.4** (in.) Rod and Bar (Angled)
Pipe Material: **Clay** ☐ Pipe Lined
Invert Depth: **8.84** (ft.) Flow Characteristics: **Slow**
Deposits: ☒ None ☐ Mud ☐ Sludge ☐ Debris ☐ Grease
Silt Depth: **0** (in.) Deposits Extent:
Infiltration: **None** Pipe Seal Cond: **Sound**

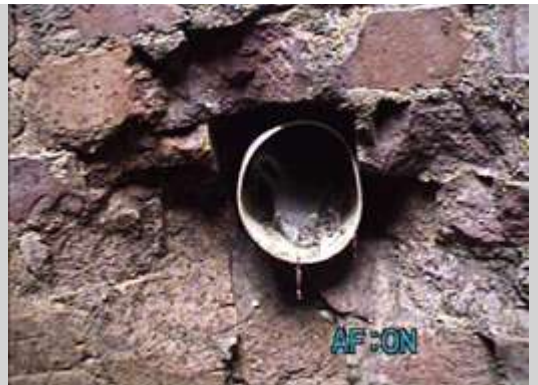
5 O'Clock Inflow

Pipe Height: **6** (in.) Rod and Bar (Angled)
Pipe Material: **Clay** ☐ Pipe Lined
Invert Depth: **4.10** (ft.) Flow Characteristics: **None**
Deposits: ☒ None ☐ Mud ☐ Sludge ☐ Debris ☐ Grease
Silt Depth: **0** (in.) Deposits Extent:
Infiltration: **None** Pipe Seal Cond: **Sound**

Drop: **Outside** Rod and Bar
Angled: **Yes** Reading: **6.91** (ft.)
Inv Depth: **7.91** (ft.)

Drop Condition: **Open**

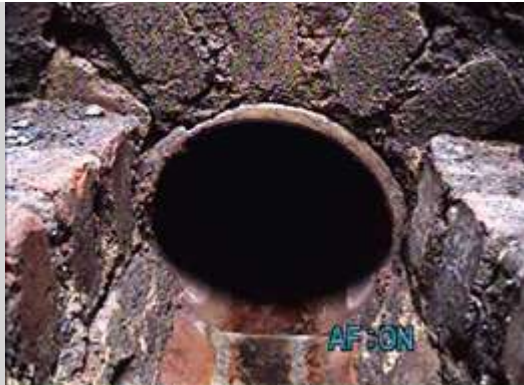
9 O'Clock Inflow

Infiltration: **None** Pipe Seal Cond: **Sound**
